CFD simulation of multiple dust explosion occurred in a flour mill

CFD simulation of multiple dust explosion occurred in a flour mill / Russo, Patrizia; Tabib, Achraf; Mazzaro, M.; Danzi, E.; Marmo, L.. - In: CHEMICAL ENGINEERING TRANSACTIONS. - ISSN 2283-9216. - ELETTRONICO. - 77:(2019), pp. 865-870. [10.3303/CET1977145]

## CFD Simulation of Multiple Dust Explosion Occurred in a Flour Mill

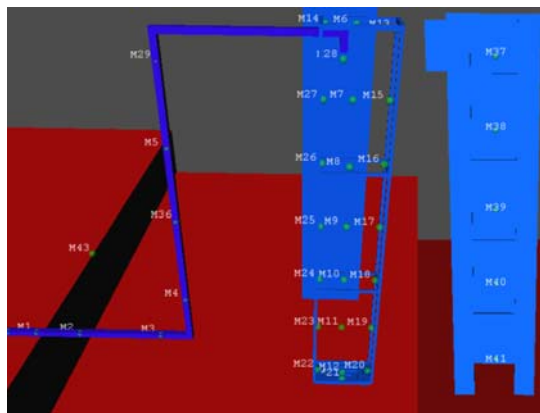
Figure 4. Positions of the monitor points.

To follow the value of parameters as temperature, maximum pressure ( $P_{max}$ ), dust concentration, velocity in time and space, some monitors points were set inside the simulation volume. The monitors were located inside the pipe, the silo, the roof, the hoist and the goods receipt area as shown in Figure 4.

Monitor Point Position	
1 to 5,	Pipe
29 to 36	
6 to 28	Silo
43	Goods receipt area
42	Under-roof area
37 to 41	Hoist
